CONTRIBUTING RESOURCE
MARYLAND HISTORICAL TRUST
INTERNAL NR-ELIGIBILITY REVIEW FORM

Property Name: Building 11 Greenhouse Range 1 Survey Number: PG:61-19

RANGE 1, BELTSVILLE AGRICULTURAL RESEARCH CENTER

NATIONAL REGISTER OF HISTORIC PLACES
REGISTRATION FORM

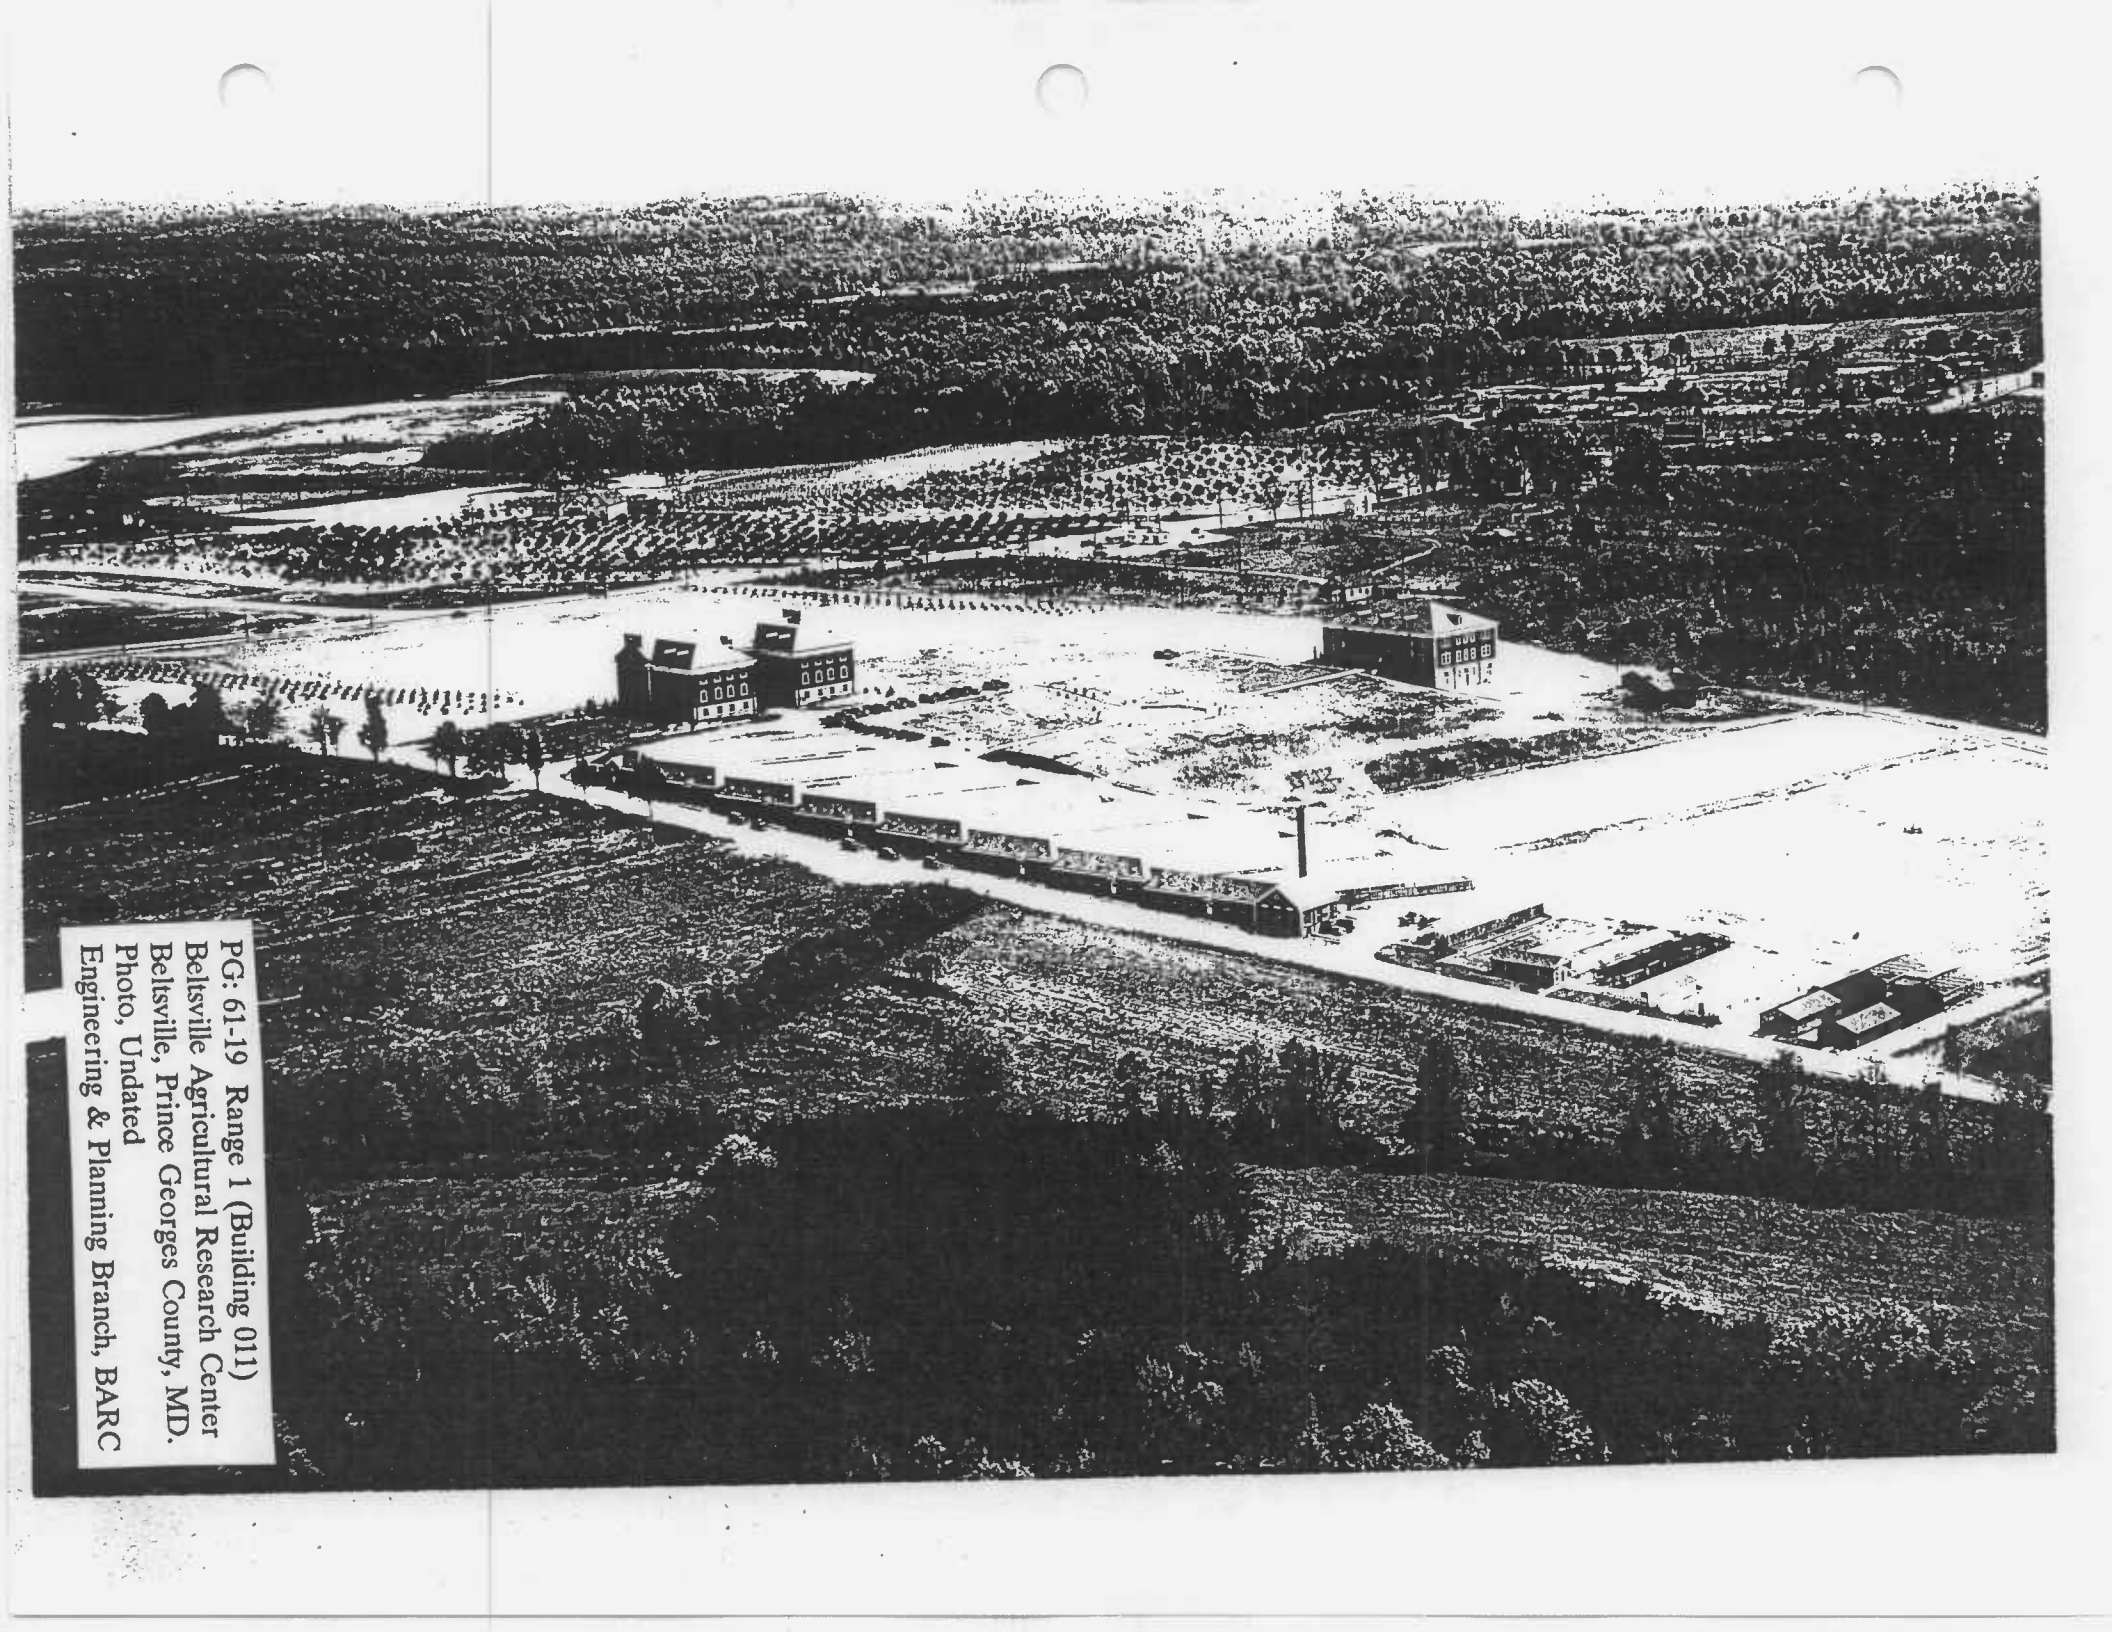
PG: 61-19 Range 1 (Building 011)
Beltsville Agricultural Research Center
Beltsville, Prince Georges County, MD.
Photo, Undated
Engineering & Planning Branch, BARC

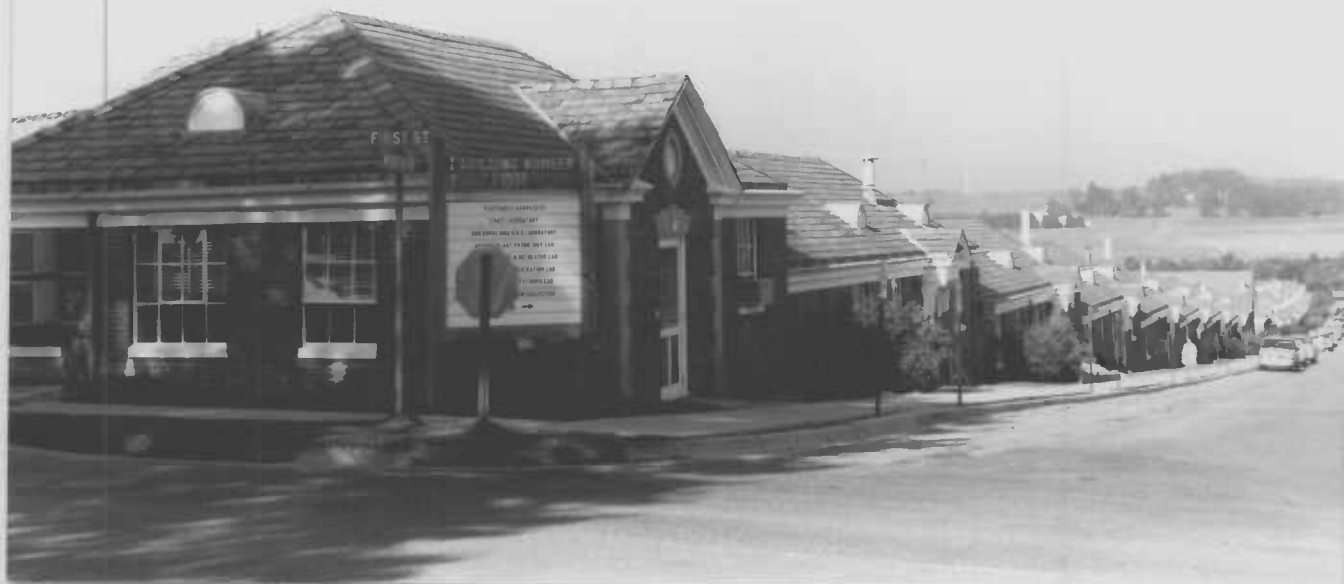
1/6

Front (Northeast) Facade, View From East

The two headhouses, although not constructed at the same time, were designed to be virtually identical on the front (main) facade. Both buildings use the same Georgian Revival decorative motifs and the same materials including brick veneer walls (over concrete block construction), concrete foundations, copper downspouts and gutters, slate roofs, and metal windows. Windows and doors are also consistent for the two buildings. The casement-style windows consist of twelve panes, the central four of which pivot from the top. Doors are half-glass with a single wood panel below and nine panes above. The ventilators/dormers on both buildings are half round.

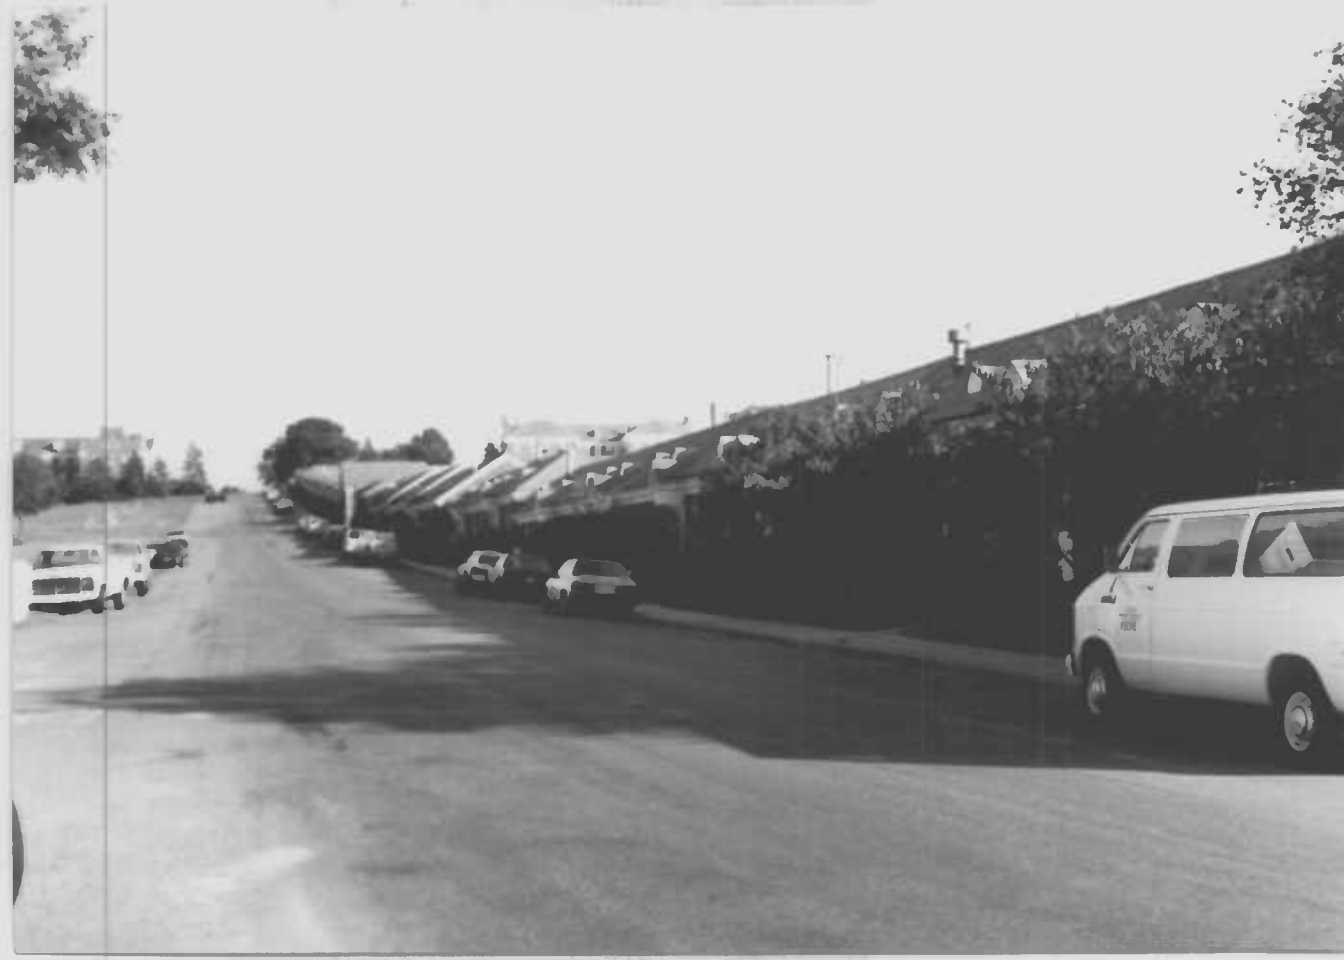
2/6

Front (North East) Facade, View From West

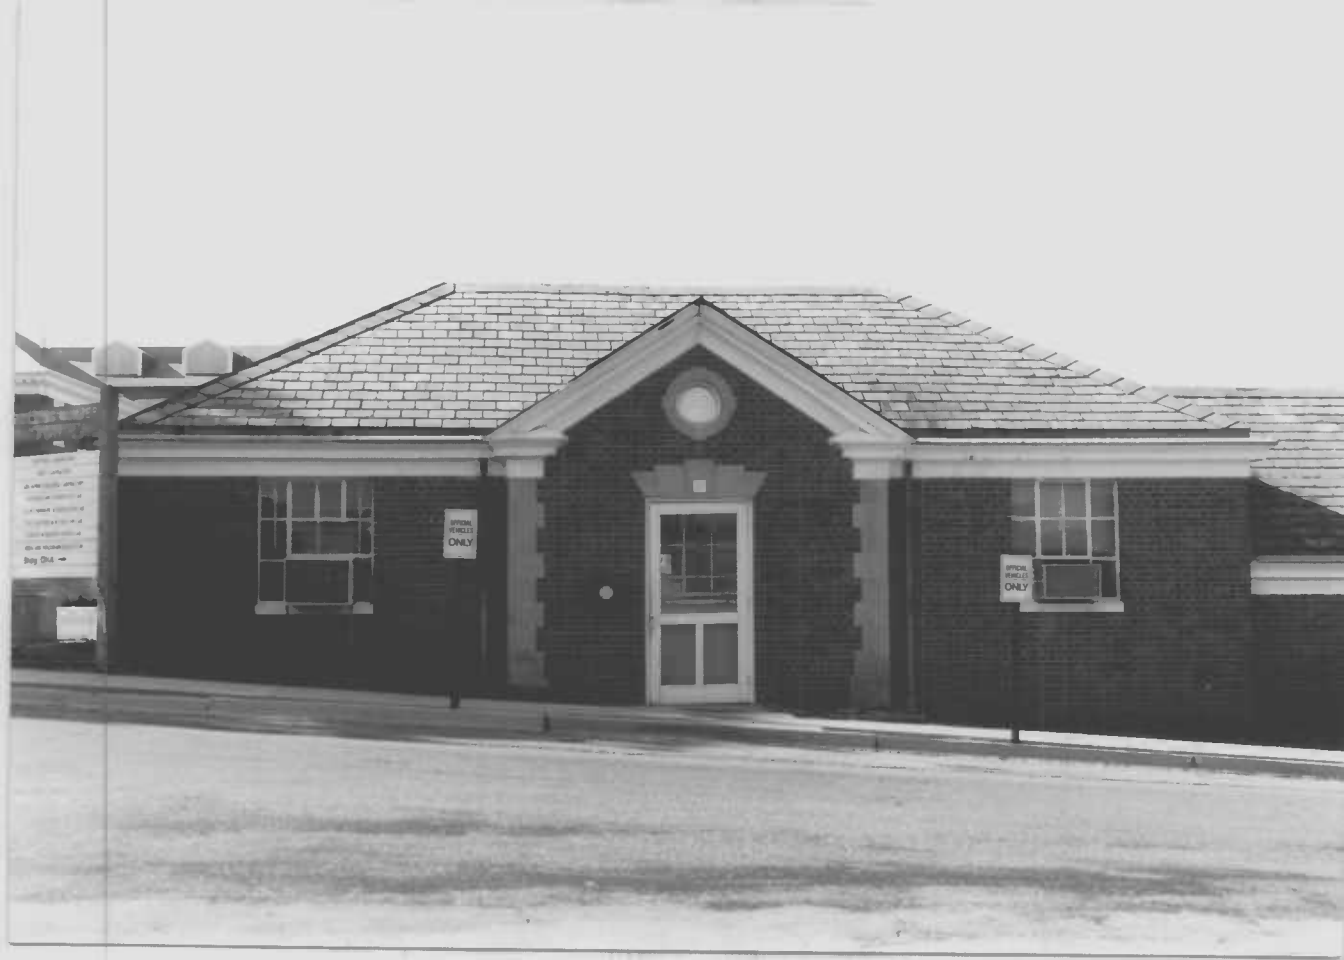
3/0

Headhouse 1

sections. This central portion of the building has a gabled roof with dormer/ventilators located over the first, third, and fifth bays of each section. The entrances to the building in this section have projecting pediments with supporting decorative brackets.

The slightly more elaborate end-sections of the building frame the central section. The east end is developed as a separate pavilion with a hipped roof and a central, projecting gabled section. Its central projecting section has stone quoining with stone keystones above the door, and a single round ventilator delineated with stone to match the quoining. The west section is longer than the other sections and includes a section similar to the six middle sections and a pavilion constructed as the power house at its end. The power house section has a cross gable and three bays all of which are windows. Decorative stone is also used for quoining at the flat arch above the windows and surrounding the single round ventilator that is centered in the middle of the section of the building. The window openings in this section are longer than those on the rest of the facade; they originally consist of 24 panes in a fixed metal window, but are now bricked in. The side elevations of the two end sections are simpler but largely similar to the front facade.

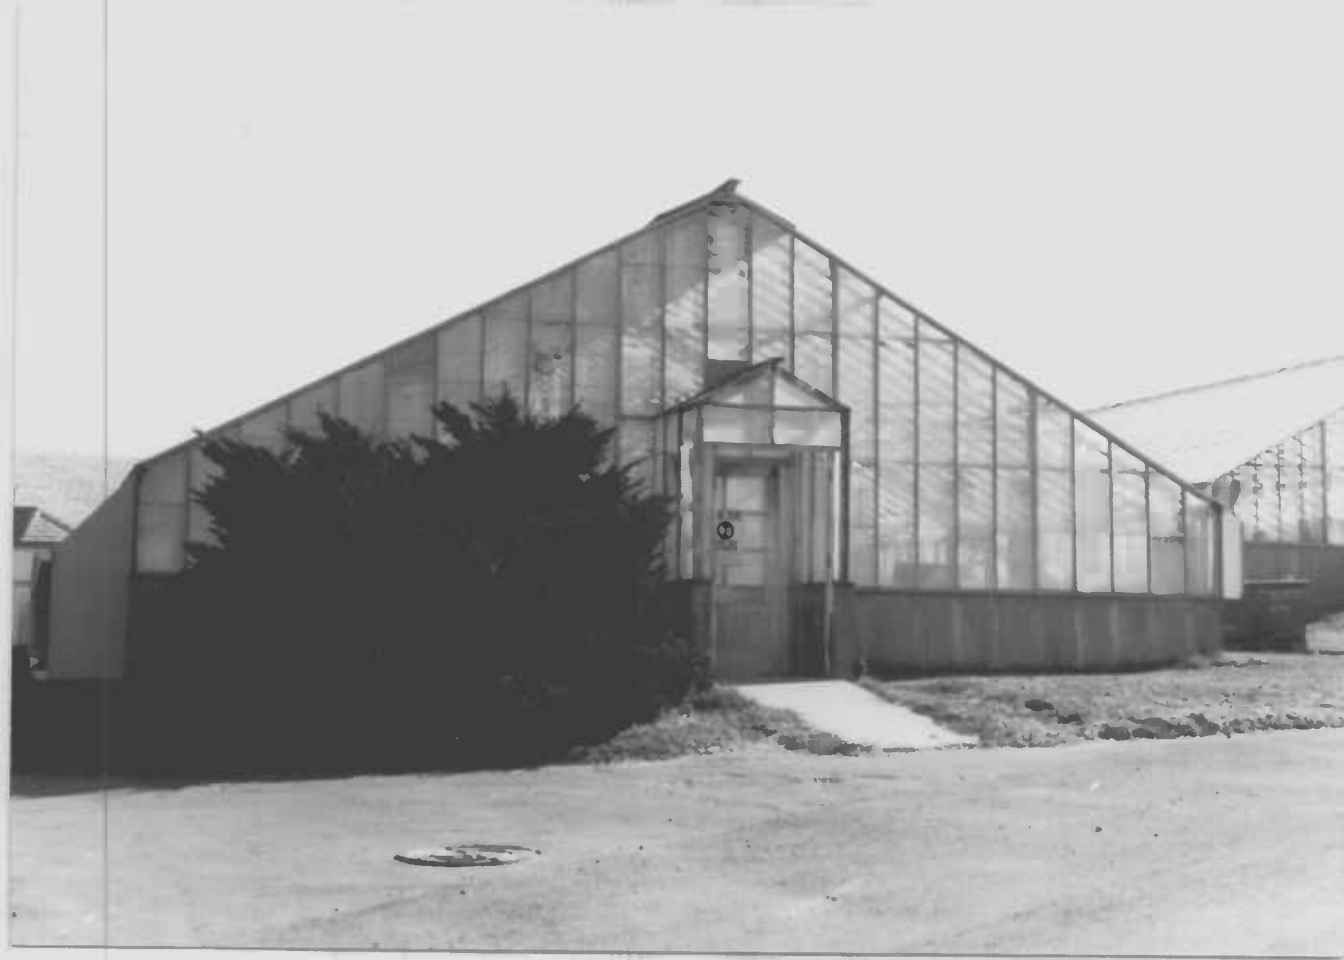
4/6

Greenhouse 3

The visible section of the rear facade of the building consists almost exclusively of the greenhouses. Each greenhouse is roughly 125 feet long and 35 1/2 feet wide with eaves roughly 6 feet above the floor of the house. The houses are attached to the headhouses at a 60-degree angle. The greenhouses are of the "half-iron" type of frame construction -- meaning all doors, frames, sash, sills, ridges, etc. used in the building are of tidewater red cypress, while all other fittings are of galvanized metal. The buildings are gabled roofed with eaves, of the "angle iron" type. Glass is double-strength A- quality glass cut in 16" x 24" panels. Panels on the side walls and the ridge open for ventilation. These sash are operated by an arm-and-rod type of vent gear with a hand wheel.

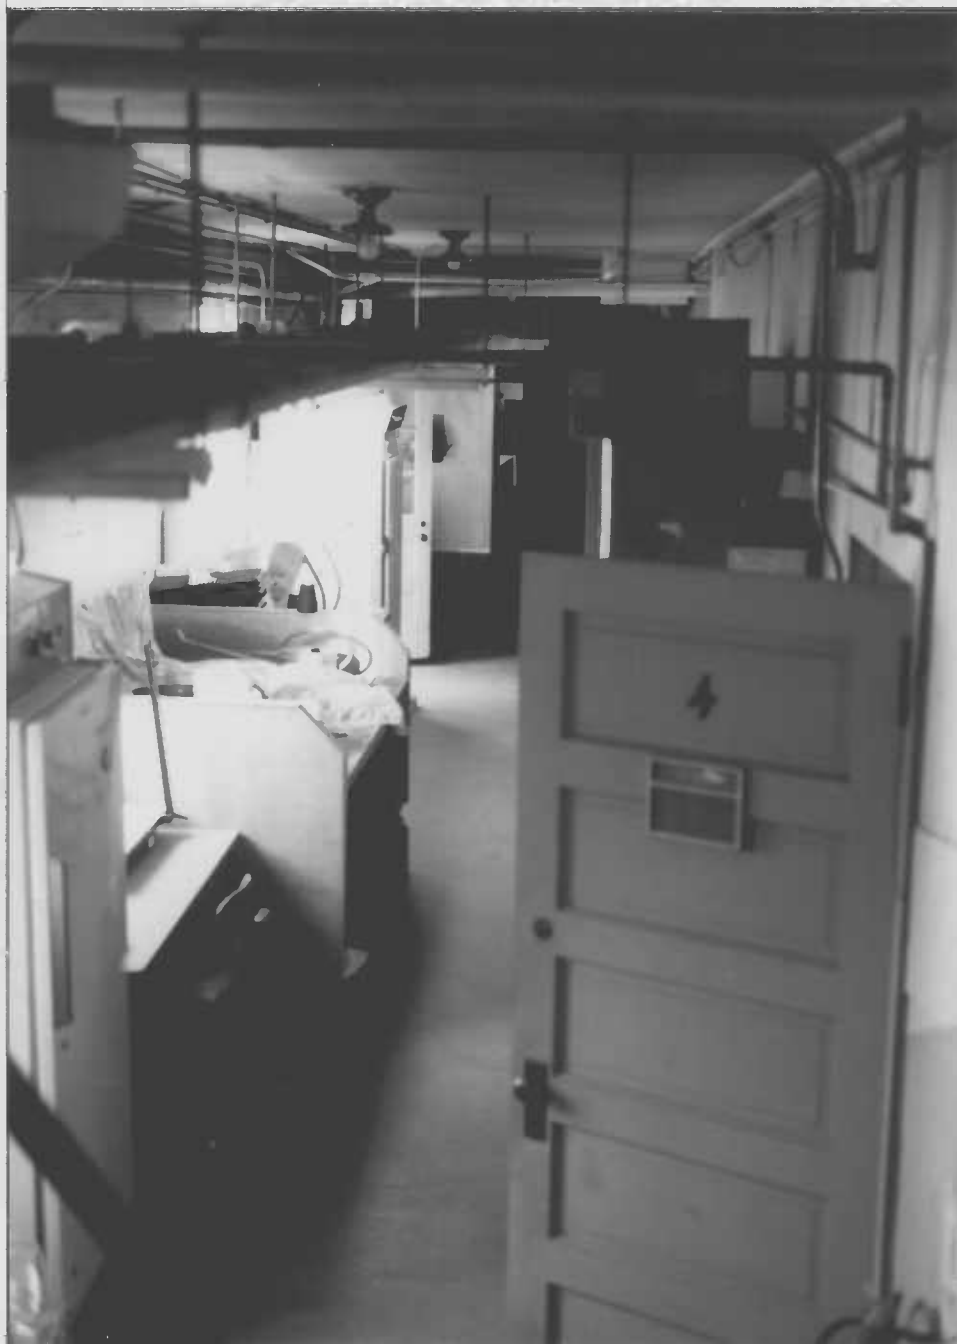
5/6

Interior of Headhouse

The interiors of the headhouses are utilitarian, with simple wood molding, exposed piping, and concrete floors. In general, their floor plan consists of an entrance way, with storage or laboratory space to either side. Leading off the entrance way is the "work space," an area that acts as a hallway

connecting the headhouses as well as an area for potting, or equipment storage. Stairs to the upper story, which is used for storage space, are also located in the work space. Access to the greenhouse is through a door in the work space aligned with the entrance door.
